To: Je vacation[jeevacation@gmail.com]
From: Ivjet [REDACTED]
Sent: Fri 1/29/2010 12:11:31 PM
Subject: Re: S76 update

Jeffrey and Darren,

Here are my findings at this time:

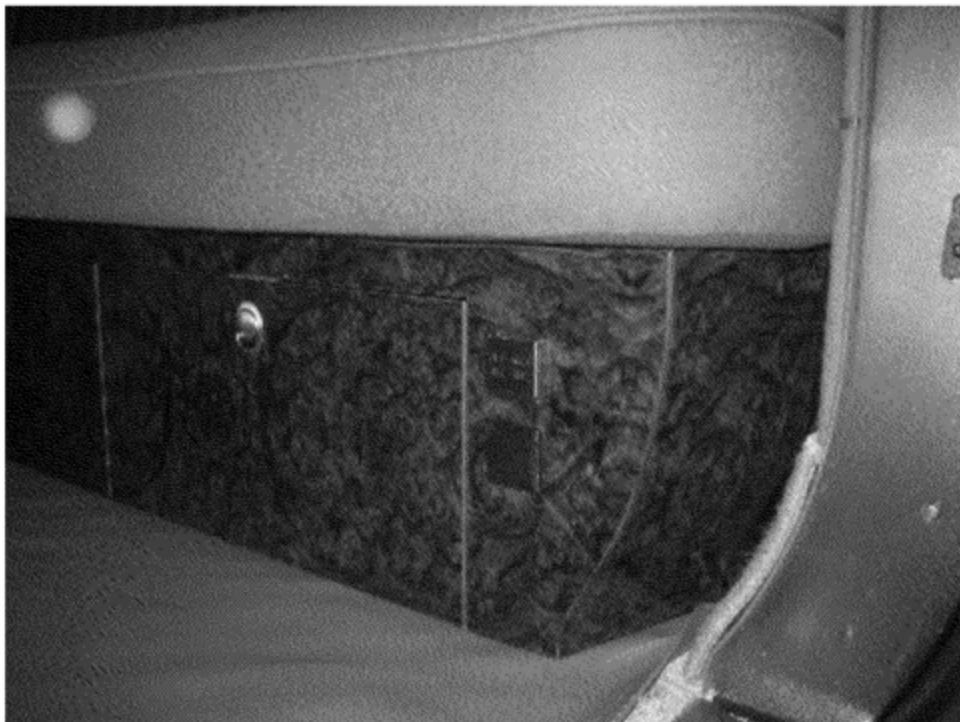
11 missing 12 Volt outlets need to be installed and functional check

-The S76 will not be fully complete till Feb 10th, Keystone is waiting for two 12 volt outlets to be delivered, they are installed in the passenger compartment.

We have four total installed in the passenger compartment, however Keystone realized they where missing two of these outlets, at this time they have installed cover plates: see photo below:
